# DEVELOPMENT, TESTING AND EVALUATION OF MHD-MATERIALS

Quarterly Report

for the period October - December 1976

H. P. R. Frederikse, T. Negas and S. J. Schneider

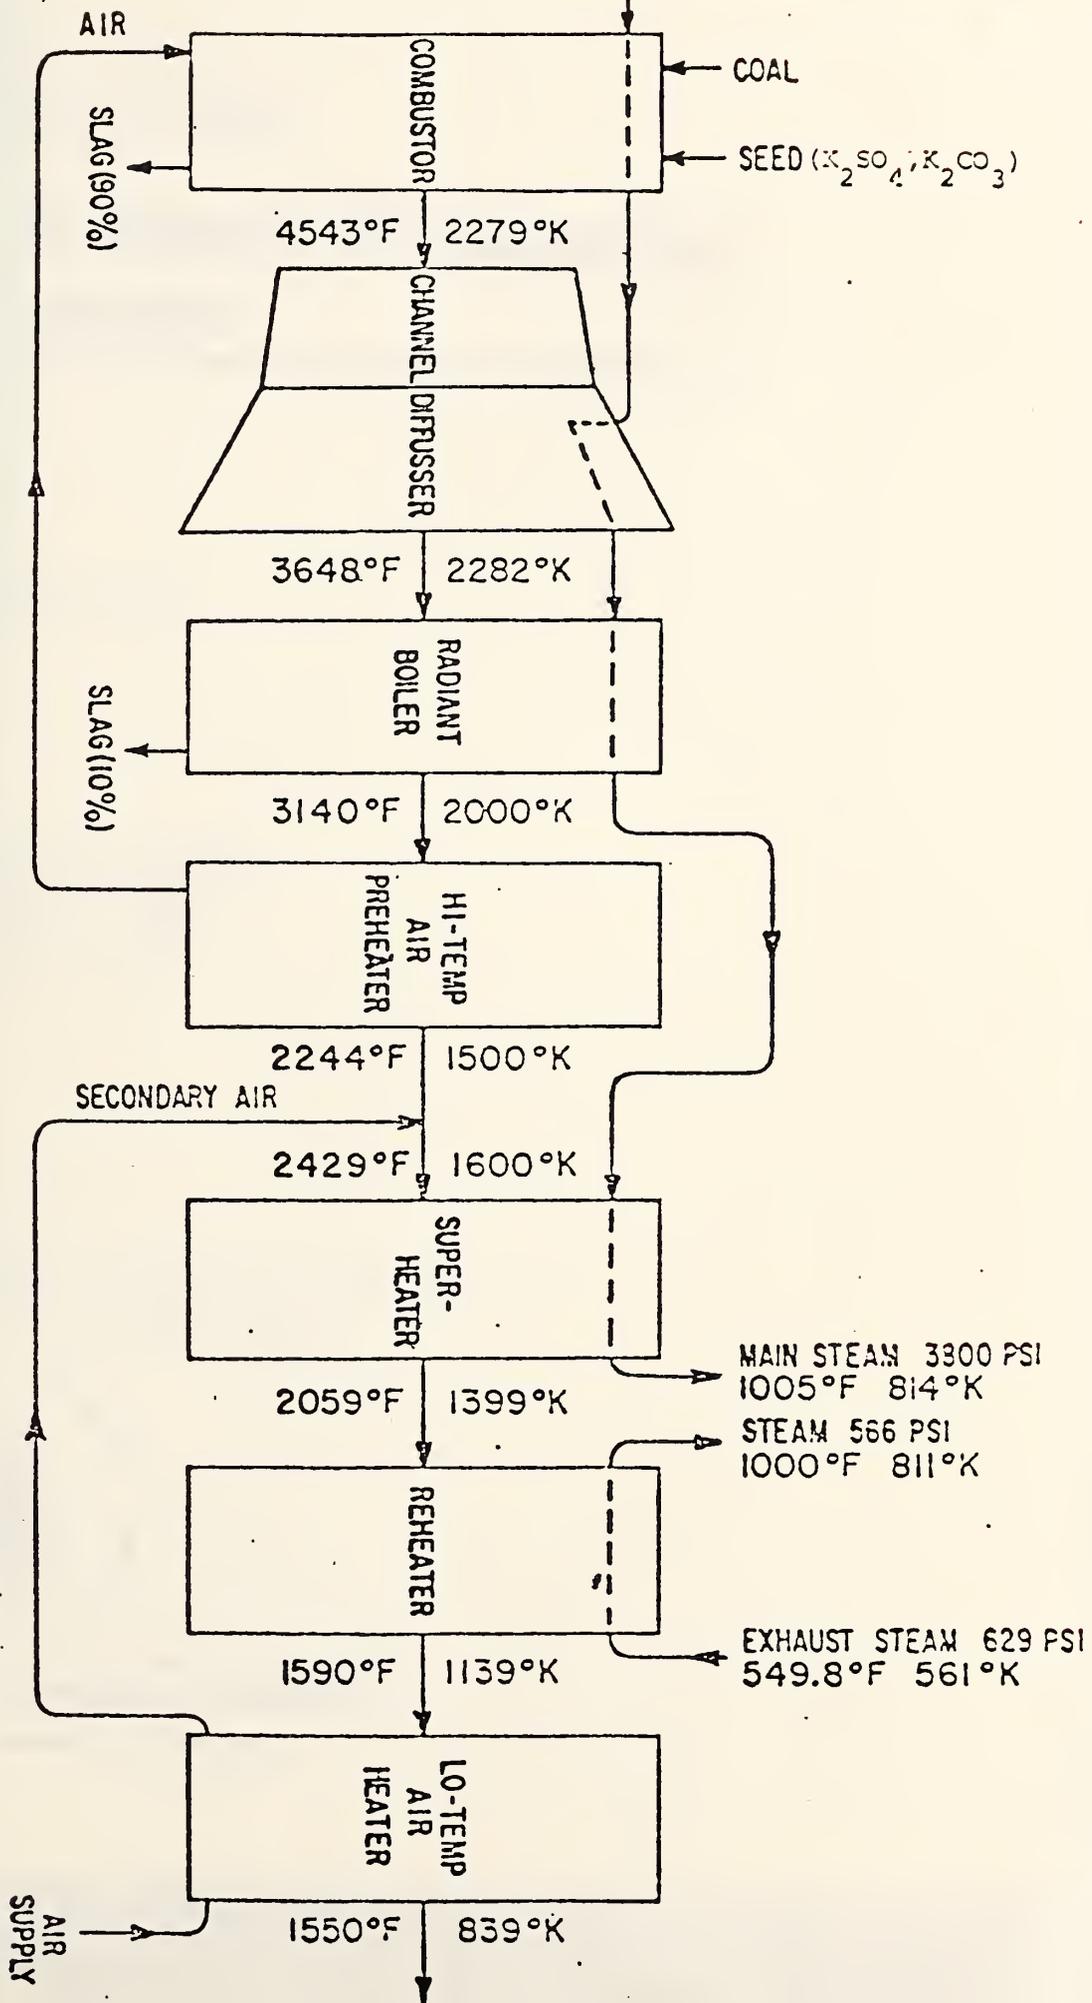
Figure 2. Baseline Reference Design for an Open Cycle MHD Power Plant.
